**CANADIAN FORCES
FLIGHT SAFETY INVESTIGATION REPORT (FSIR)**

FINAL REPORT

FILE NUMBER: 1010-CC130327 (DFS 2-2-3)
DATE OF REPORT: 3 November 2005

AIRCRAFT TYPE: CC130 Hercules
DATE/TIME: 290505Z July 2003
LOCATION: Kabul Area
CATEGORY: "E" Category Incident (Accident Potential)

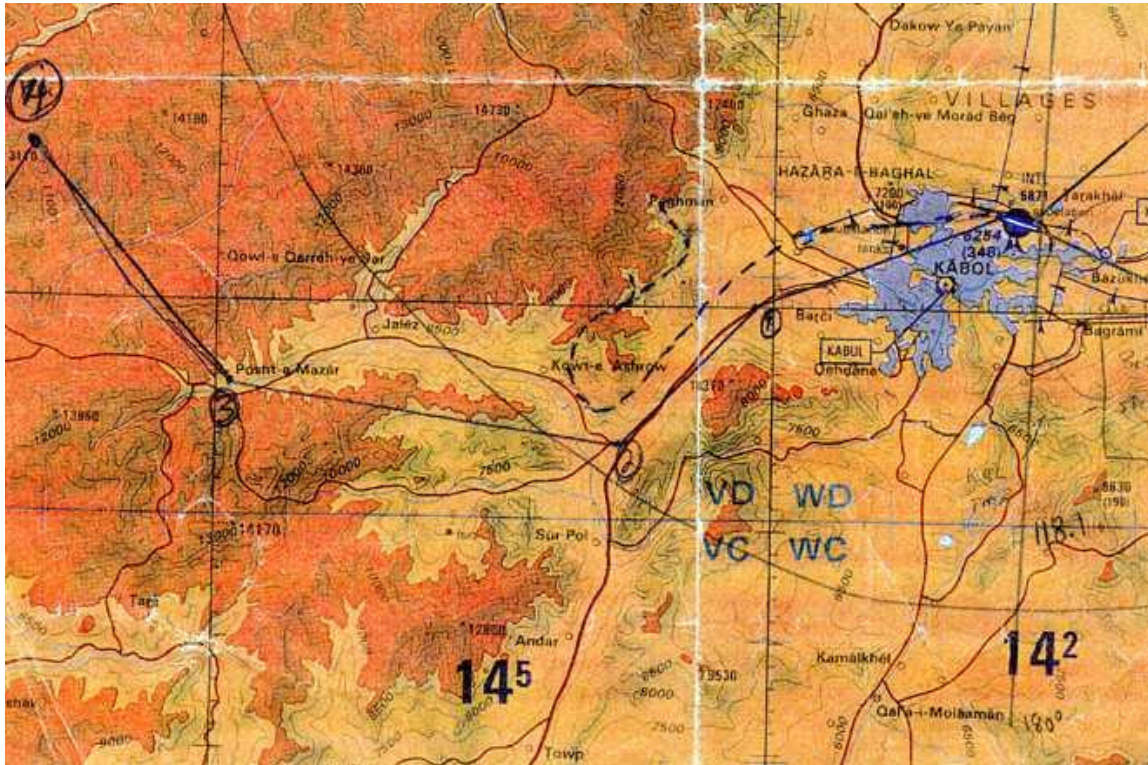
ANNEX A: MAP

The primary navigational tool was the standard 1:250,000-scale map with the Flight Management System (FMS) blended navigation solution of the global positioning system (GPS) and the inertial navigation system (INS) being used as a backup. The FMS was configured to show four waypoints between Kabul and the start of the instrument flying rule (IFR) corridor, which would route the aircraft back to Camp MIRAGE (see Annex A).

The departure navigation was based on a 1:250000 map using terrain features as a guide. The incident crew stated that this map scale proved difficult for them to use in mountainous areas due to a lack of detail. The FMS was programmed with four waypoints and was being used to provide general track guidance. Following passage of waypoint #2, it became apparent that the intended valley had been misidentified and the aircraft was proceeding in the wrong direction. The "direct-to" feature of the FMS was utilized to provide directional guidance to the initial point of the enroute segment. The FMS indicated that a left-hand turn was required, and the crew commenced a left-hand turn into a large, broad valley. The crew believed they were now heading in generally the desired direction and they were aware that they were not in the valley they had intended to transit. This second valley however, had rising terrain, and housed an unseen finger ridge. As a result of this navigational error, the crew had unknowingly placed themselves in a box canyon situation.

1:250,000-scale map showing FMS waypoints and the aircraft's ground track (dashed line).
